**Flood Control Project Maintenance  
Levee Inspections**

**Maintenance Issue Types Only, Levee Inspection Report By Mile - Fall 2018**

**Reclamation District No. 2060 Hastings**

Waterway	Bank	Unit Miles	Inspection Start/End	Inspector
Unit No. 01 Lindsey Slough	Left	6.97	10/25/2018 10/25/2018	David Julian

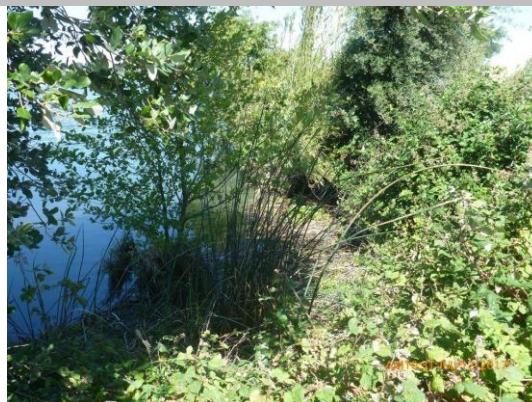
Photo 2 of 6 : FA\_2018\_RD2060\_241\_5\_20180925\_00002.jpg

LM Start	0.40	Rating **	M	Issue No.	5 (cont)	
LM End	0.40	Issue Type +	Ma	Location *	WS	
Category	Supplemental			GPS Latitude/Longitude		
				Start		End
Item	2017 Storm Damage			38.247894 °		38.247911 °
				-121.703492 °		-121.703539 °
DWR ID	DWR_RD2060_01_f _ 2017_5					
Comment Code						
Inspector Comment						
Levee Evaluation Comments						
Description:Erosion commences approximately 3/4 of the way down the slope, near the water line towards the waterside toe.						
Site ID No:358						
Site Designation:LMA-185						
Repair Type: Erosion						
Rating:Area of Concern						
Field Date:7/12/2017						
Notes: Small erosion into bank.

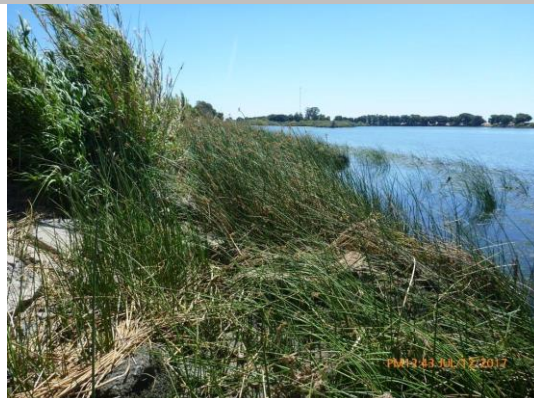
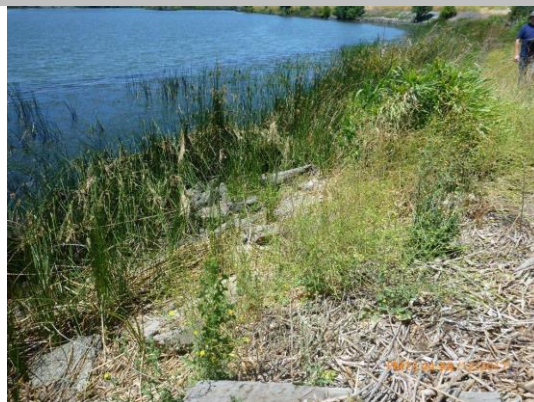
LM Start	0.92	Rating **	M	Issue No.	10
LM End	0.93	Issue Type +	Ma	Location *	WS
Category	Supplemental			GPS Latitude/Longitude	
				Start	End
Item	2017 Storm Damage			38.250875 °	38.250953 °
				-121.711942 °	-121.712078 °
DWR ID	DWR_RD2060_01_f_2018_10				
Comment Code					
Inspector Comment					
Levee Evaluation Comments					
Description:Sloughing commences approximately halfway down the water side slope.					
Site ID No:361					
Site Designation:LMA-188					
Repair Type: Erosion					
Rating:Area of Concern					
Field Date:7/12/2017					
Notes: Minor sloughing, mostly riprap has moved down the slope and into channel.

LM Start	0.92	Rating **	M	Issue No.	10 (cont)
LM End	0.93	Issue Type +	Ma	Location *	WS
Category	Supplemental			GPS Latitude/Longitude	
				Start	End
Item	2017 Storm Damage			38.250875 °	38.250953 °
				-121.711942 °	-121.712078 °
DWR ID	DWR_RD2060_01_f_2018_10				
Comment Code					
Inspector Comment					
Levee Evaluation Comments					
Description:Sloughing commences approximately halfway down the water side slope.					
Site ID No:361					
Site Designation:LMA-188					
Repair Type: Erosion					
Rating:Area of Concern					
Field Date:7/12/2017					
Notes: Minor sloughing, mostly riprap has moved down the slope and into channel.

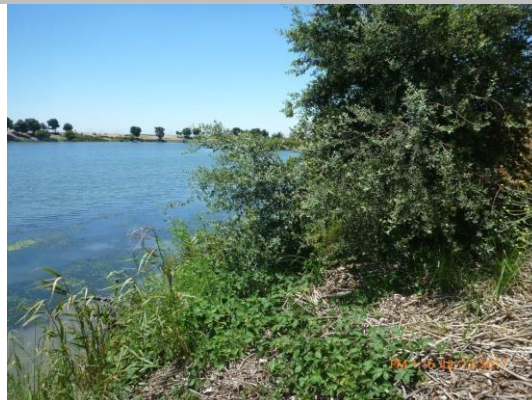
Photo 2 of 3 : FA\_2018\_RD2060\_241\_15\_20180925\_00018.jpg

LM Start	1.04	Rating **	M	Issue No.	15
LM End	1.08	Issue Type +	Ma	Location *	WS
Category	Supplemental			GPS Latitude/Longitude	
				Start	End
Item	2017 Storm Damage			38.251058 °	38.250872 °
				-121.714050 °	-121.714792 °
DWR ID	DWR_RD2060_01_f_2017_15				
Comment Code					
Inspector Comment					
Levee Evaluation Comments					
Description:Erosion commences approximately 3/4 of the way down the water side slope concentrated at the waterline.					
Site ID No:362					
Site Designation:LMA-189					
Repair Type: Erosion					
Rating:Area of Concern					
Field Date:7/12/2017					
Notes: Erosion due to lack of revetment. Erosion ends at riprap downstream. Vertical cut at summer wse.

LM Start	1.04	Rating **	M	Issue No.	15 (cont)
LM End	1.08	Issue Type +	Ma	Location *	WS
Category	Supplemental			GPS Latitude/Longitude	
				Start	End
Item	2017 Storm Damage			38.251058 °	38.250872 °
				-121.714050 °	-121.714792 °
DWR ID	DWR_RD2060_01_f_2017_15				
Comment Code					
Inspector Comment					
Levee Evaluation Comments					
Description:Erosion commences approximately 3/4 of the way down the water side slope concentrated at the waterline.					
Site ID No:362					
Site Designation:LMA-189					
Repair Type: Erosion					
Rating:Area of Concern					
Field Date:7/12/2017					
Notes: Erosion due to lack of revetment. Erosion ends at riprap downstream. Vertical cut at summer wse.

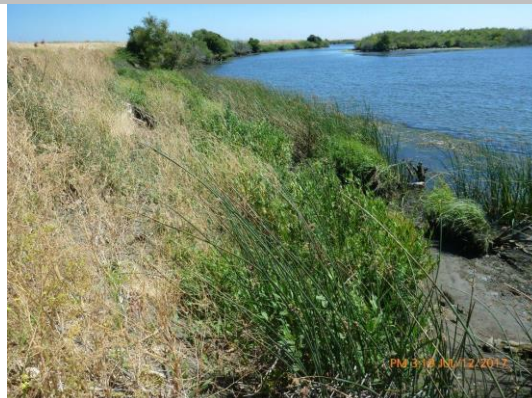
Photo 1 of 3 : FA\_2018\_RD2060\_241\_21\_20180925\_00029.jpg

LM Start	1.81	Rating **	A/W	Issue No.	21 (cont)
LM End	1.84	Issue Type +	Ma	Location *	WS
Category	Supplemental			GPS Latitude/Longitude	
				Start	End
Item	2017 Storm Damage			38.255972 °	38.256247 °
				-121.724197 °	-121.724464 °
DWR ID	DWR_RD2060_01_f_2017_21				
Comment Code					
Inspector Comment					
Levee Evaluation Comments					
Description:Erosion commences approximately halfway down the water side slope extending to the toe. Some slipping into the toe has occurred due to deep erosion.					
Site ID No:366					
Site Designation:LMA-193					
Repair Type: Erosion					
Rating:Serious					
Field Date:7/12/2017					
Notes: Erosion extends halfway into the slope.

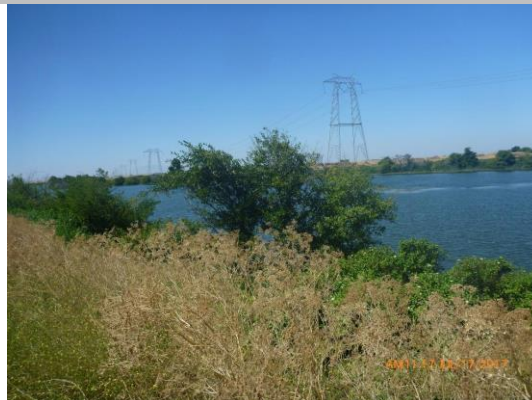
Photo 3 of 3 : FA\_2018\_RD2060\_241\_22\_20180925\_00034.jpg

LM Start	1.90	Rating **	M	Issue No.	22
LM End	1.95	Issue Type +	Ma	Location *	WS
Category	Supplemental			GPS Latitude/Longitude	
				Start	End
Item	2017 Storm Damage			38.257208 °	38.257842 °
				-121.724619 °	-121.724694 °
DWR ID	DWR_RD2060_01_f_2017_22				
Comment Code					
Inspector Comment					
Levee Evaluation Comments					
Description:Erosion commences approximately halfway down the water side slope extending to the toe. Some slipping into the toe has occurred.					
Site ID No:367					
Site Designation:LMA-194					
Repair Type: Erosion					
Rating:Area of Concern					
Field Date:7/12/2017					
Notes: Minor crackingobserved below the hinge point and minor erosion at levee toe.

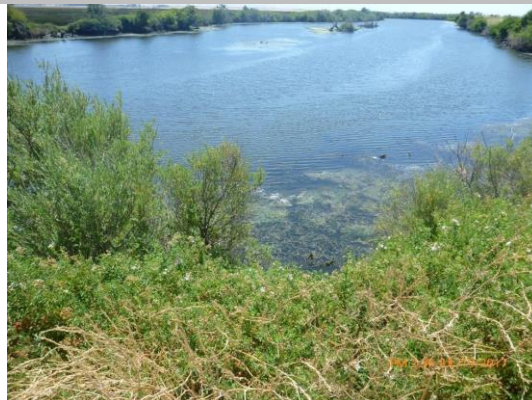
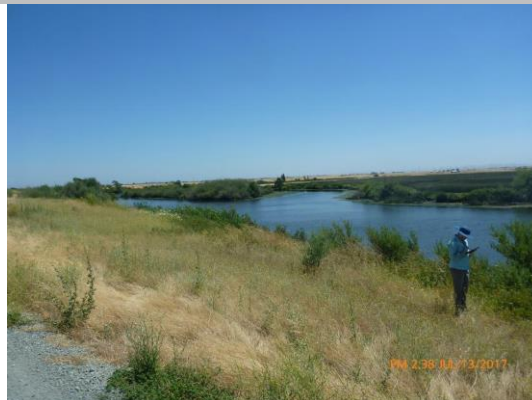
LM Start	4.28	Rating **	A/W	Issue No.	29
LM End	4.28	Issue Type +	Ma	Location *	
Category	Supplemental			GPS Latitude/Longitude	
				Start	End
Item	2017 Storm Damage			38.260992 °	38.261017 °
				-121.759806 °	-121.759847 °
DWR ID	DWR_RD2060_01_f_2017_29				
Comment Code					
Inspector Comment					
Levee Evaluation Comments					
Description:Erosion commences halfway down the slope and extends to the toe. Erosion is concentrated at the water line.					
Site ID No:376					
Site Designation:LMA-203					
Repair Type: Erosion					
Rating:Area of Concern					
Field Date:7/13/2017					
Notes: Could not get to erosion due to dense veg. Possibly a deep narrow cut.

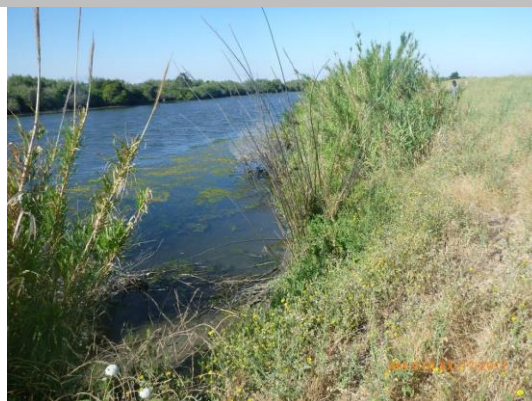
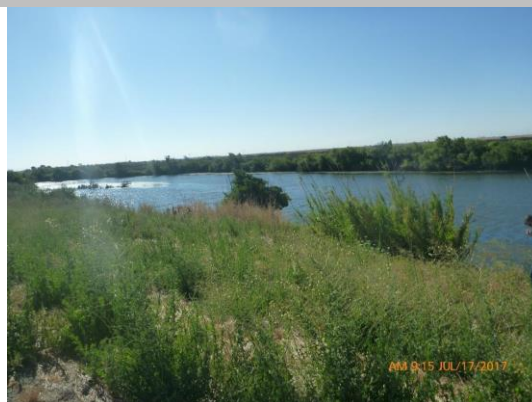
LM Start	4.50	Rating **	A/W	Issue No.	31
LM End	4.53	Issue Type +	Ma	Location *	
Category	Supplemental			GPS Latitude/Longitude	
				Start	End
Item	2017 Storm Damage			38.260150°	38.259939°
				-121.763556°	-121.764064°
DWR ID	DWR_RD2060_01_f_2017_31				
Comment Code					
Inspector Comment					
Levee Evaluation Comments					
Description:Erosion commences approximately 3/4 of the way down the slope. It has resulted in some sloughing.					
Site ID No:378					
Site Designation:LMA-205					
Repair Type: Erosion					
Rating:Serious					
Field Date:7/17/2017					
Notes: Deep, wide, vertical cut into slope almost 1/2 way into sope.

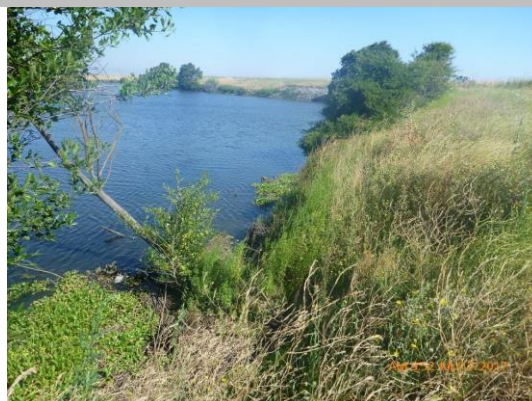
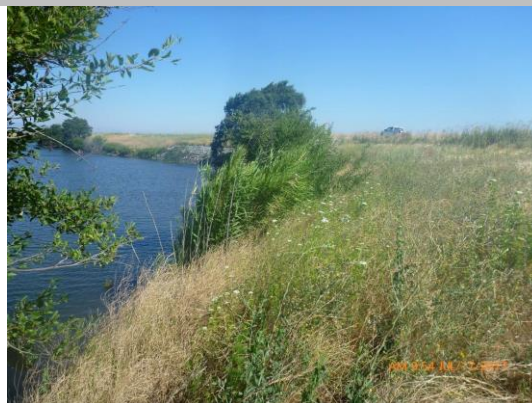
LM Start	4.80	Rating **	A/W	Issue No.	32 (cont)	
LM End	4.88	Issue Type +	Ma	Location *		
Category	Supplemental			GPS Latitude/Longitude		
				Start	End	
Item	2017 Storm Damage			38.260714 °	38.261808 °	
				-121.767972 °	-121.768536 °	
DWR ID	DWR_RD2060_01_f_2017_32					
Comment Code						
Inspector Comment						
Levee Evaluation Comments						
Description: Erosion/sloughing commences approximately halfway down the slope. Erosion is concentrated mostly near the water line and has resulting in slippage of the slope towards the toe.						
Site ID No: 379						
Site Designation: LMA-206						
Repair Type: Erosion						
Rating: Serious						
Field Date: 7/17/2017						
Notes: Several erosions with slumping. Fresh soil indicates active erosion this season. Adjacent slope has riprap. Riprap should be extended along this stretch.

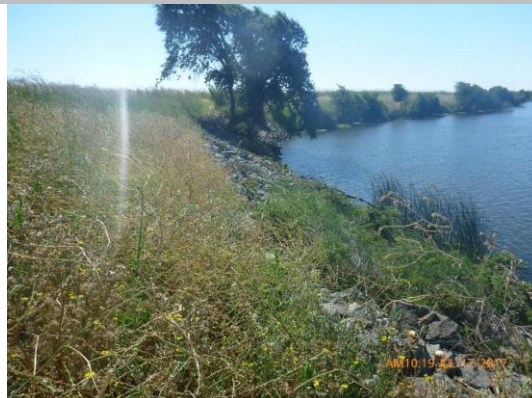
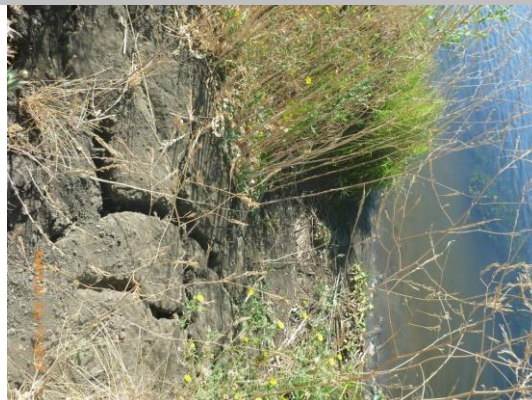
LM Start	4.92	Rating **	M	Issue No.	33
LM End	4.92	Issue Type +	Ma	Location *	
Category	Supplemental			GPS Latitude/Longitude	
				Start	End
Item	2017 Storm Damage			38.262128°	38.262128°
				-121.769175°	-121.769175°
DWR ID	DWR_RD2060_01_f_2017_33				
Comment Code					
Inspector Comment					
Levee Evaluation Comments					
Description:Erosion/sloughing commences approximately halfway down the slope. Erosion is concentrated mostly near the water line and has resulting in slippage of the slope into the toe.					
Site ID No:380					
Site Designation:LMA-207					
Repair Type: Erosion					
Rating:Area of Concern					
Field Date:7/17/2017					
Notes: Reduced length of site from 275 to 62. No widespread erosion, just 2 small erosions upstream from adjacent riprap.

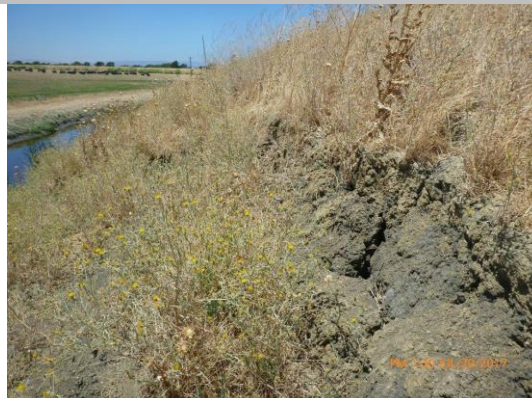
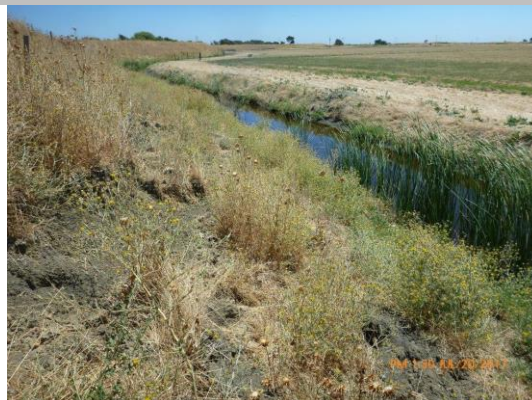
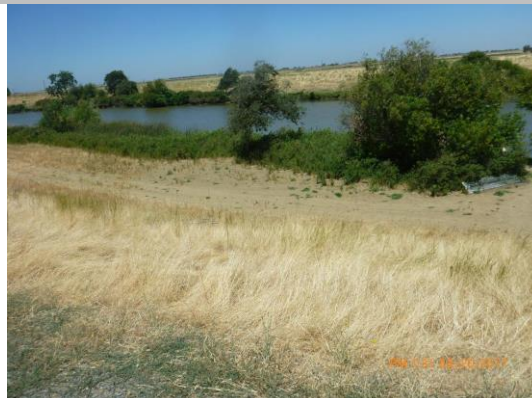
LM Start	0.12	Rating **	M	Issue No.	13
LM End	0.18	Issue Type +	Ma	Location *	
Category	Supplemental			GPS Latitude/Longitude	
				Start	End
Item	2017 Storm Damage			38.295919 °	38.295611 °
				-121.746700 °	-121.745742 °
DWR ID	DWR_RD2060_03_f_2017_13				
Comment Code					
Inspector Comment					
Levee Evaluation Comments					
Description:Sloughing and seepage occurs near the land side toe.					
Site ID No:385					
Site Designation:LMA-212					
Repair Type: Stability					
Rating:Area of Concern					
Field Date:7/20/2017					
Notes: Moderate sloughing halfway down LS slope. Monitor for progression.

LM Start	0.12	Rating **	M	Issue No.	13 (cont)
LM End	0.18	Issue Type +	Ma	Location *	
Category	Supplemental			GPS Latitude/Longitude	
				Start	End
Item	2017 Storm Damage			38.295919 °	38.295611 °
				-121.746700 °	-121.745742 °
DWR ID	DWR_RD2060_03_f _ 2017_13				
Comment Code					
Inspector Comment					
Levee Evaluation Comments					
Description:Sloughing and seepage occurs near the land side toe.					
Site ID No:385					
Site Designation:LMA-212					
Repair Type: Stability					
Rating:Area of Concern					
Field Date:7/20/2017					
Notes: Moderate sloughing halfway down LS slope. Monitor for progression.

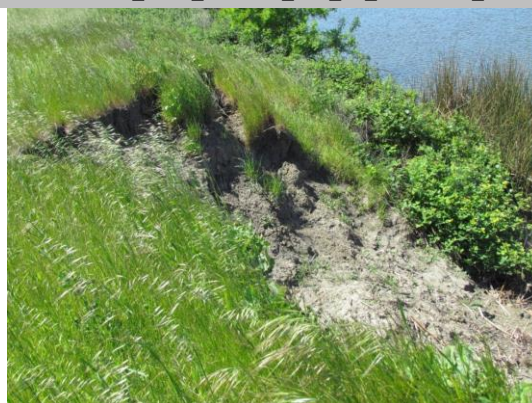
Photo 2 of 2 : FA\_2018\_RD2060\_243\_18\_20180925\_00013.jpg

Looking upstream at the erosion on the waterside slope.

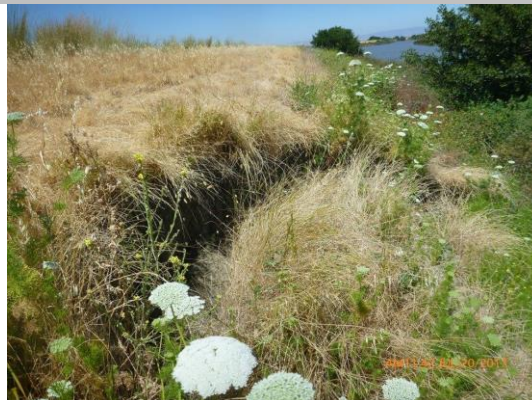
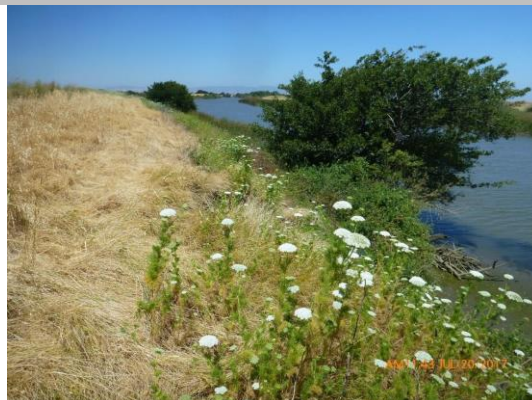
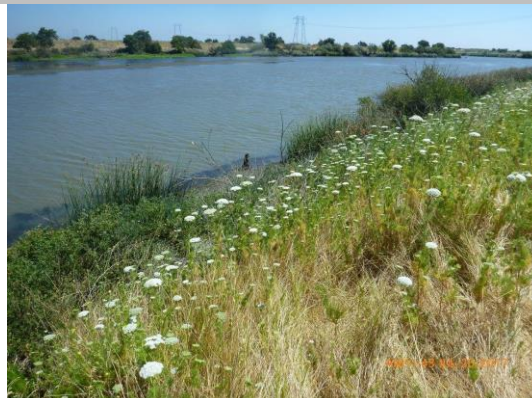
LM Start	1.21	Rating **	M	Issue No.	20
LM End	1.23	Issue Type +	Ma	Location *	
Category	Supplemental			GPS Latitude/Longitude	
				Start	End
Item	2017 Storm Damage			38.290511 °	38.290486 °
				-121.729867 °	-121.729603 °
DWR ID	DWR_RD2060_03_f _ 2017_20				
Comment Code					
Inspector Comment					
Levee Evaluation Comments					
Description:Erosion commences 1/4 of the way down the slope with					
slippage towards the water side toe.					
Site ID No:390					
Site Designation:LMA-217					
Repair Type: Erosion					
Rating:Area of Concern					
Field Date:7/20/2017					
Notes: Erosion halfway down WS slope. Monitor for progression.

LM Start	1.21	Rating **	M	Issue No.	20 (cont)	
LM End	1.23	Issue Type +	Ma	Location *		
Category	Supplemental			GPS Latitude/Longitude		
				Start		End
Item	2017 Storm Damage			38.290511 °		38.290486 °
				-121.729867 °		-121.729603 °
DWR ID	DWR_RD2060_03_f _ 2017_20					
Comment Code						
Inspector Comment						
Levee Evaluation Comments						
Description:Erosion commences 1/4 of the way down the slope with slippage towards the water side toe.						
Site ID No:390						
Site Designation:LMA-217						
Repair Type: Erosion						
Rating:Area of Concern						
Field Date:7/20/2017						
Notes: Erosion halfway down WS slope. Monitor for progression.

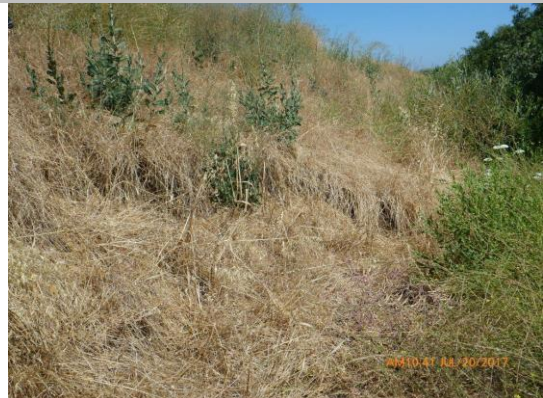
Photo 2 of 3 : FA\_2018\_RD2060\_243\_23\_20180925\_00026.jpg

LM Start	1.62	Rating **	A/W	Issue No.	23
LM End	1.63	Issue Type +	Ma	Location *	
Category	Supplemental			GPS Latitude/Longitude	
				Start	End
Item	2017 Storm Damage			38.287336 °	38.287222 °
				-121.724364 °	-121.724253 °
DWR ID	DWR_RD2060_03_f_2017_23				
Comment Code					
Inspector Comment					
Levee Evaluation Comments					
Description:Erosion commences halfway down the slope and results in slippage into the waterside toe. Existing rip rap has sloughed into the water side toe.					
Site ID No:393					
Site Designation:LMA-220					
Repair Type: Erosion					
Rating:Serious					
Field Date:7/20/2017					
Notes: Moderate sloughing 8ft from WS crown. Erosion at high water mark.

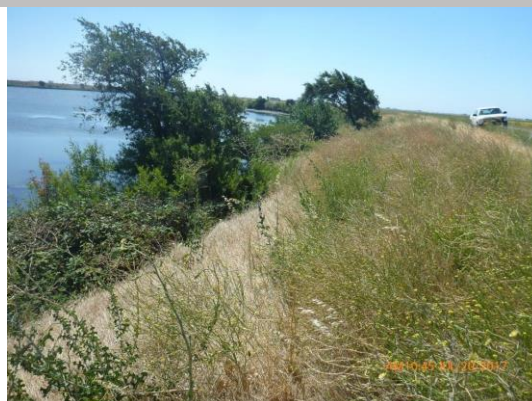
Photo 3 of 3 : FA\_2018\_RD2060\_243\_23\_20180925\_00027.jpg

LM Start	<b>1.62</b>	Rating **	A/W	Issue No.	<b>23 (cont)</b>							
LM End	<b>1.63</b>	Issue Type +	Ma	Location *								
Category	Supplemental		GPS Latitude/Longitude									
			Start	End								
Item	2017 Storm Damage		38.287336°	38.287222°								
			-121.724364°	-121.724253°								
DWR ID	DWR_RD2060_03_f_2017_23											
Comment Code												
Inspector Comment												
Levee Evaluation Comments Description: Erosion commences halfway down the slope and results in slippage into the waterside toe. Existing rip rap has sloughed into the water side toe. Site ID No: 393 Site Designation: LMA-220 Repair Type: Erosion Rating: Serious Field Date: 7/20/2017 Notes: Moderate sloughing 8ft from WS crown. Erosion at high water mark.

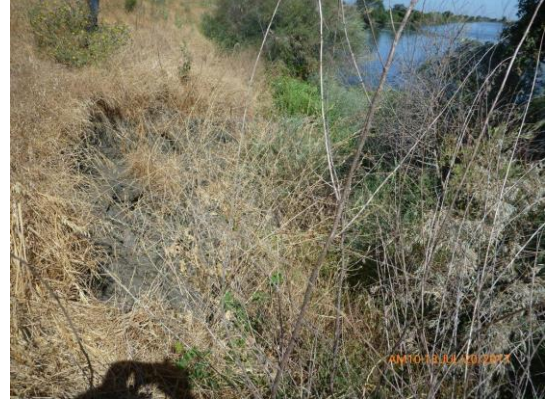
Photo 1 of 3 : FA\_2018\_RD2060\_243\_25\_20180925\_00028.jpg

Levee Evaluation Comments
Description:Erosion commences halfway down the slope and results in slippage into the waterside toe.
Site ID No:395
Site Designation:LMA-222
Repair Type: Erosion
Rating:Area of Concern
Field Date:7/20/2017
Notes: Erosion halfway down slope. Monitor for progression.

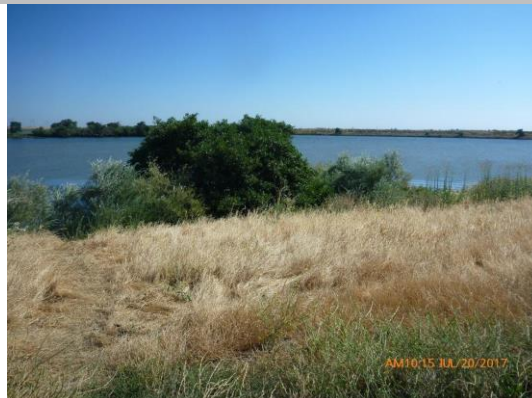
Photo 3 of 3 : FA\_2018\_RD2060\_243\_25\_20180925\_00030.jpg

LM Start	1.84	Rating **	M	Issue No.	25 (cont)	
LM End	1.92	Issue Type +	Ma	Location *		
Category	Supplemental			GPS Latitude/Longitude		
				Start	End	
Item	2017 Storm Damage			38.284825 °	38.284467 °	
				-121.721764 °	-121.720339 °	
DWR ID	DWR_RD2060_03_f _ 2017_25					
Comment Code						
Inspector Comment						
Levee Evaluation Comments						
Description:Erosion commences halfway down the slope and results in						
slippage into the waterside toe.						
Site ID No:395						
Site Designation:LMA-222						
Repair Type: Erosion						
Rating:Area of Concern						
Field Date:7/20/2017						
Notes: Erosion halfway down slope. Monitor for progression.

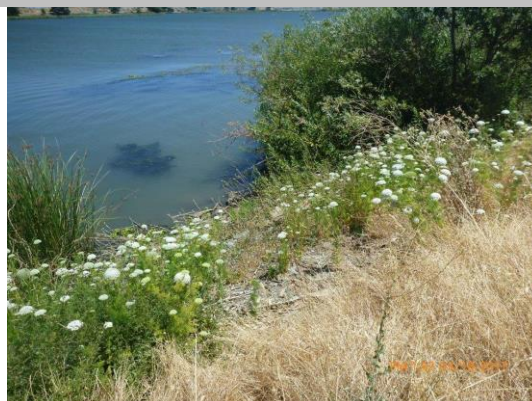
Photo 2 of 3 : FA\_2018\_RD2060\_243\_26\_20180925\_00032.jpg

LM Start	2.02	Rating **	M	Issue No.	26 (cont)
LM End	2.06	Issue Type +	Ma	Location *	
Category	Supplemental			GPS Latitude/Longitude	
				Start	End
Item	2017 Storm Damage			38.283914 °	38.283422 °
				-121.718614 °	-121.718206 °
DWR ID	DWR_RD2060_03_f_2017_26				
Comment Code					
Inspector Comment					
Levee Evaluation Comments					
Description:Erosion commences halfway down the slope and results in slippage into the waterside toe. Existing rip rap has sloughed into the water side toe.					
Site ID No:396					
Site Designation:LMA-223					
Repair Type: Erosion					
Rating:Area of Concern					
Field Date:7/18/2017					
Notes: Erosion to high water line.

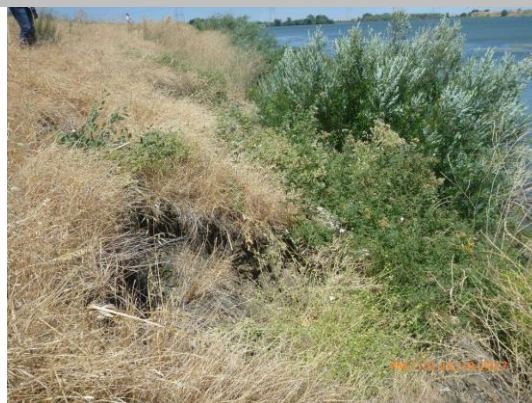
Photo 1 of 3 : FA\_2018\_RD2060\_243\_27\_20180925\_00034.jpg

LM Start	2.12	Rating **	A/W	Issue No.	27
LM End	2.15	Issue Type +	Ma	Location *	
Category	Supplemental			GPS Latitude/Longitude	
				Start	End
Item	2017 Storm Damage			38.282733 °	38.282403 °
				-121.717683 °	-121.717428 °
DWR ID	DWR_RD2060_03_f_2017_27				
Comment Code					
Inspector Comment					
Levee Evaluation Comments					
Description:Erosion commences approximately 1/4 of the way down the slope and results in slippage into the waterside toe.					
Site ID No:397					
Site Designation:LMA-224					
Repair Type: Erosion					
Rating:Serious					
Field Date:7/18/2017					
Notes: Benched erosion with large cracks on slope above. Light veg in erosion.

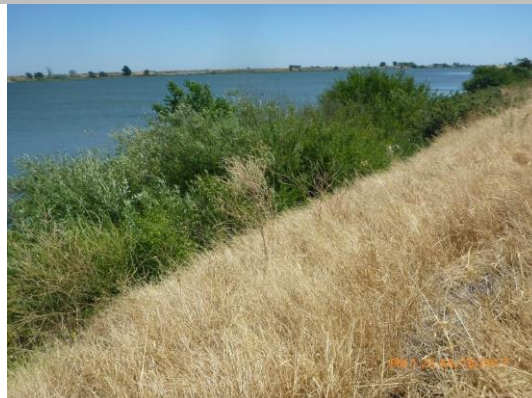
Photo 3 of 3 : FA\_2018\_RD2060\_243\_27\_20180925\_00036.jpg

LM Start	2.12	Rating **	A/W	Issue No.	27 (cont)
LM End	2.15	Issue Type +	Ma	Location *	
Category	Supplemental			GPS Latitude/Longitude	
				Start	End
Item	2017 Storm Damage			38.282733 °	38.282403 °
				-121.717683 °	-121.717428 °
DWR ID	DWR_RD2060_03_f_2017_27				
Comment Code					
Inspector Comment					
Levee Evaluation Comments					
Description:Erosion commences approximately 1/4 of the way down the slope and results in slippage into the waterside toe.					
Site ID No:397					
Site Designation:LMA-224					
Repair Type: Erosion					
Rating:Serious					
Field Date:7/18/2017					
Notes: Benched erosion with large cracks on slope above. Light veg in erosion.

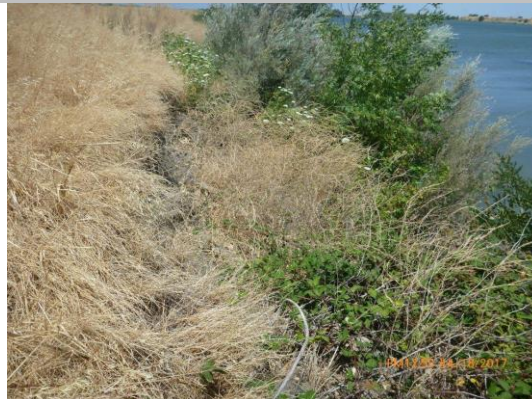
Photo 1 of 3 : FA\_2018\_RD2060\_243\_28\_20180925\_00037.jpg

LM Start	2.19	Rating **	A/W	Issue No.	28
LM End	2.22	Issue Type +	Ma	Location *	
Category	Supplemental			GPS Latitude/Longitude	
				Start	End
Item	2017 Storm Damage			38.281839 °	38.281486 °
				-121.716964 °	-121.716661 °
DWR ID	DWR_RD2060_03_f_2017_28				
Comment Code					
Inspector Comment					
Levee Evaluation Comments					
Description:Erosion commences approximately 1/4 of the way down the slope and results in slippage into the waterside toe.					
Site ID No:398					
Site Designation:LMA-225					
Repair Type: Erosion					
Rating:Serious					
Field Date:7/18/2017					
Notes: Erosion is near vertical with light veg. Existing rip rap to the left of site.

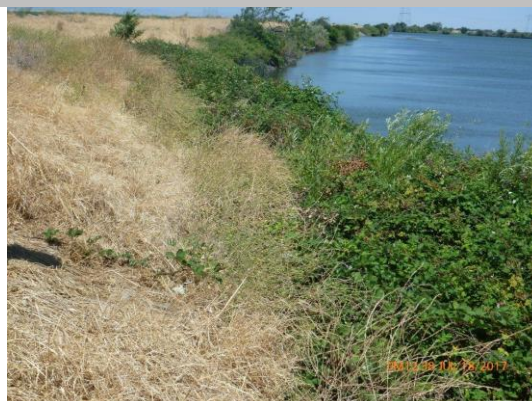
Photo 3 of 3 : FA\_2018\_RD2060\_243\_29\_20180925\_00042.jpg

LM Start	2.30	Rating **	M	Issue No.	29 (cont)	
LM End	2.33	Issue Type +	Ma	Location *		
Category	Supplemental			GPS Latitude/Longitude		
				Start		End
Item	2017 Storm Damage			38.280667°		38.280467°
				-121.715664°		-121.715242°
DWR ID	DWR_RD2060_03_f _ 2017_29					
Comment Code						
Inspector Comment						
Levee Evaluation Comments						
Description:Erosion commences approximately halfway down the slope and results in slippage into the waterside toe.						
Site ID No:399						
Site Designation:LMA-226						
Repair Type: Erosion						
Rating:Area of Concern						
Field Date:7/18/2017						
Notes: Vertical erosion at high water mark.

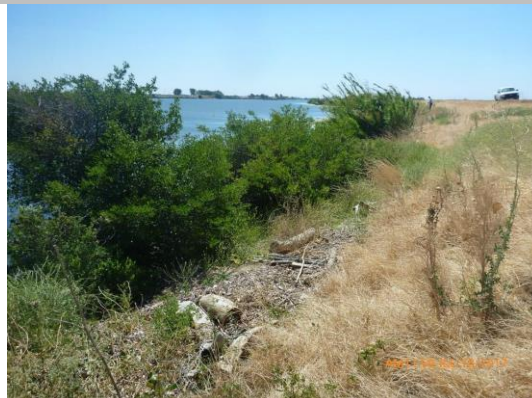
Photo 2 of 3 : FA\_2018\_RD2060\_243\_31\_20180925\_00044.jpg

LM Start	2.36	Rating **	M	Issue No.	31 (cont)
LM End	2.43	Issue Type +	Ma	Location *	
Category	Supplemental			GPS Latitude/Longitude	
				Start	End
Item	2017 Storm Damage			38.280208 °	38.279336 °
				-121.714853 °	-121.714172 °
DWR ID	DWR_RD2060_03_f _ 2017_31				
Comment Code					
Inspector Comment					
Levee Evaluation Comments					
Description:Erosion commences approximately halfway down the slope and results in slippage into the waterside toe.					
Site ID No:400					
Site Designation:LMA-227					
Repair Type: Erosion					
Rating:Area of Concern					
Field Date:7/18/2017					
Notes: Steep cut but protected with heavy woody veg.

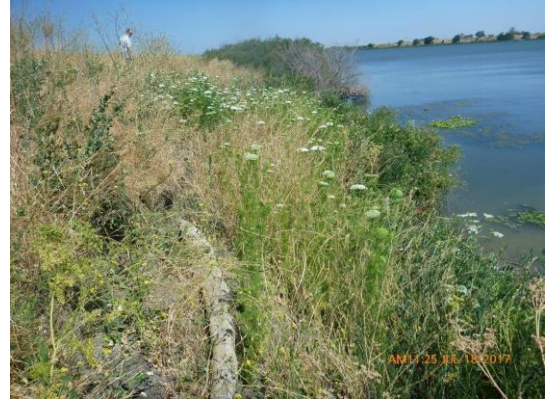
Photo 1 of 3 : FA\_2018\_RD2060\_243\_32\_20180925\_00046.jpg

Levee Evaluation Comments
Description: Erosion commences approximately halfway down the slope and results in sloughing into the waterside toe.
Site ID No: 401
Site Designation: LMA-228
Repair Type: Erosion
Rating: Area of Concern
Field Date: 7/18/2017
Notes: Erosion and sloughing. Heavy veg flanking both sides.

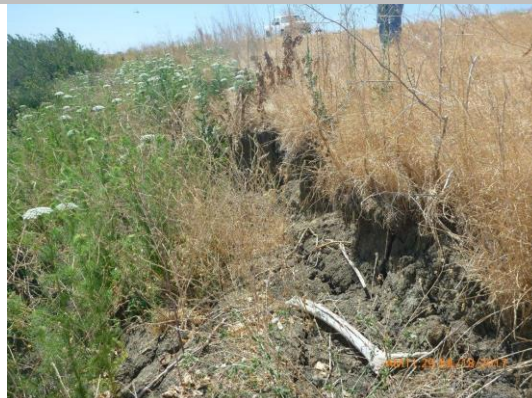
Photo 3 of 3 : FA\_2018\_RD2060\_243\_32\_20180925\_00048.jpg

LM Start	2.47	Rating **	M	Issue No.	32 (cont)
LM End	2.49	Issue Type +	Ma	Location *	
Category	Supplemental			GPS Latitude/Longitude	
				Start	End
Item	2017 Storm Damage			38.278794 °	38.278533 °
				-121.713703 °	-121.713453 °
DWR ID	DWR_RD2060_03_f _ 2017_32				
Comment Code					
Inspector Comment					
Levee Evaluation Comments					
Description:Erosion commences approximately halfway down the slope and results in sloughing into the waterside toe.					
Site ID No:401					
Site Designation:LMA-228					
Repair Type: Erosion					
Rating:Area of Concern					
Field Date:7/18/2017					
Notes: Erosion and sloughing. Heavy veg flanking both sides.

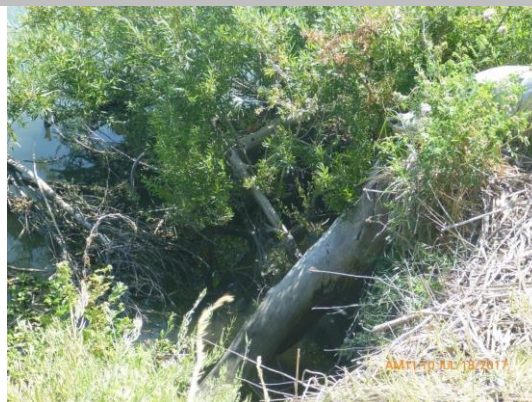
Photo 1 of 3 : FA\_2018\_RD2060\_243\_33\_20180925\_00049.jpg

LM Start	2.55	Rating **	M	Issue No.	33
LM End	2.55	Issue Type +	Ma	Location *	
Category	Supplemental			GPS Latitude/Longitude	
				Start	End
Item	2017 Storm Damage			38.277956 °	38.277928 °
				-121.712814 °	-121.712775 °
DWR ID	DWR_RD2060_03_f _ 2017_33				
Comment Code					
Inspector Comment					
Levee Evaluation Comments					
Description:Erosion commences approximately halfway down the slope and extends to the waterside toe.					
Site ID No:402					
Site Designation:LMA-229					
Repair Type: Erosion					
Rating:Area of Concern					
Field Date:7/18/2017					
Notes: Small but deep vertical cut down to water.

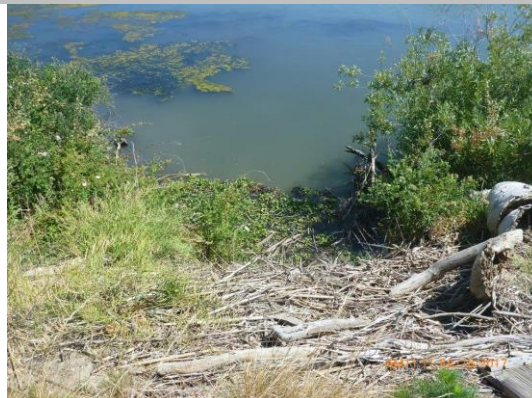
Photo 2 of 3 : FA\_2018\_RD2060\_243\_33\_20180925\_00050.jpg

LM Start	2.55	Rating **	M	Issue No.	33 (cont)	
LM End	2.55	Issue Type +	Ma	Location *		
Category	Supplemental			GPS Latitude/Longitude		
				Start	End	
Item	2017 Storm Damage			38.277956°	38.277928°	
				-121.712814°	-121.712775°	
DWR ID	DWR_RD2060_03_f_2017_33					
Comment Code						
Inspector Comment						
Levee Evaluation Comments						
Description:Erosion commences approximately halfway down the slope and extends to the waterside toe.						
Site ID No:402						
Site Designation:LMA-229						
Repair Type: Erosion						
Rating:Area of Concern						
Field Date:7/18/2017						
Notes: Small but deep vertical cut down to water.

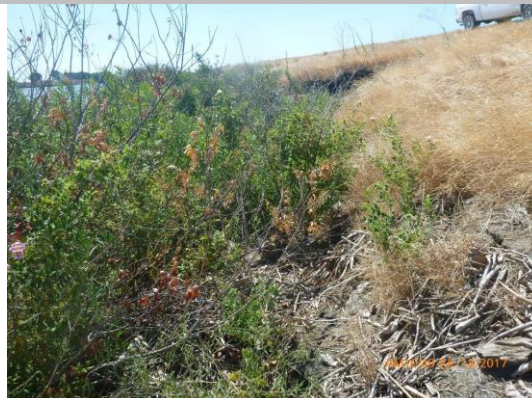
Photo 1 of 3 : FA\_2018\_RD2060\_243\_34\_20180925\_00052.jpg

Notes: Erosion causing sloughing. Horizontal cracks about 6' up from erosion.

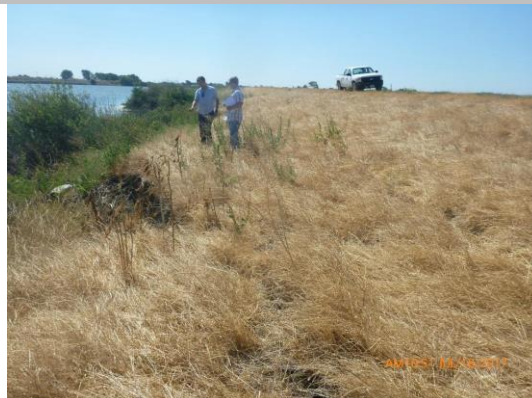
Photo 3 of 3 : FA\_2018\_RD2060\_243\_34\_20180925\_00054.jpg

LM Start	2.56	Rating **	A/W	Issue No.	34 (cont)
LM End	2.58	Issue Type +	Ma	Location *	
Category	Supplemental			GPS Latitude/Longitude	
				Start	End
Item	2017 Storm Damage			38.277850 °	38.277706 °
				-121.712639 °	-121.712414 °
DWR ID	DWR_RD2060_03_f_2017_34				
Comment Code					
Inspector Comment					
Levee Evaluation Comments					
Description:Erosion commences approximately 1/4 of the way down the slope and results in sloughing into the waterside toe.					
Site ID No:403					
Site Designation:LMA-230					
Repair Type: Erosion					
Rating:Serious					
Field Date:7/18/2017					
Notes: Erosion causing sloughing. Horizontal cracks about 6' up from erosion.

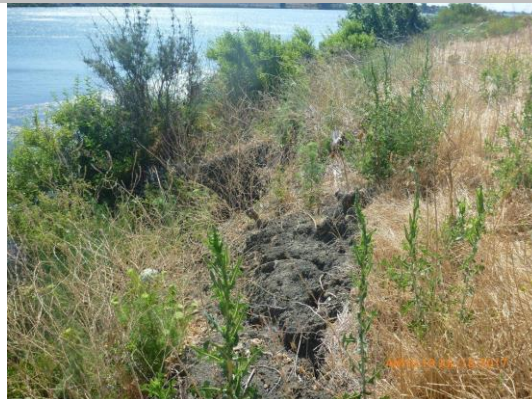
Photo 1 of 3 : FA\_2018\_RD2060\_243\_35\_20180925\_00055.jpg

LM Start	2.64	Rating **	M	Issue No.	35
LM End	2.64	Issue Type +	Ma	Location *	
Category	Supplemental			GPS Latitude/Longitude	
				Start	End
Item	2017 Storm Damage			38.277106°	38.277078°
				-121.711489°	-121.711447°
DWR ID	DWR_RD2060_03_f_2017_35				
Comment Code					
Inspector Comment					
Levee Evaluation Comments					
Description:Erosion commences approximately 1/4 of the way down the slope and results in sloughing into the waterside toe.					
Site ID No:404					
Site Designation:LMA-231					
Repair Type: Erosion					
Rating:Area of Concern					
Field Date:7/18/2017					
Notes: Small erosion and sloughing adjacent to revetted slope.

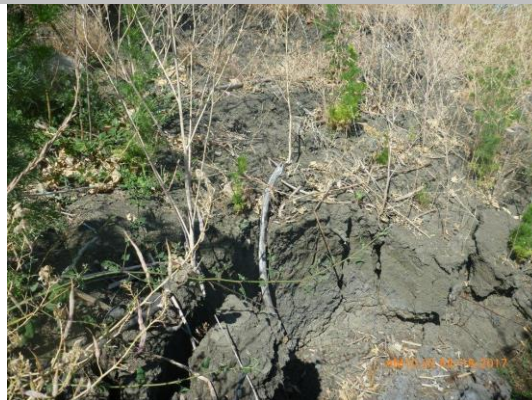
Photo 2 of 3 : FA\_2018\_RD2060\_243\_35\_20180925\_00056.jpg

LM Start	2.64	Rating **	M	Issue No.	35 (cont)	
LM End	2.64	Issue Type +	Ma	Location *		
Category	Supplemental			GPS Latitude/Longitude		
				Start		End
Item	2017 Storm Damage			38.277106°		38.277078°
				-121.711489°		-121.711447°
DWR ID	DWR_RD2060_03_f _ 2017_35					
Comment Code						
Inspector Comment						
Levee Evaluation Comments						
Description:Erosion commences approximately 1/4 of the way down the slope and results in sloughing into the waterside toe.						
Site ID No:404						
Site Designation:LMA-231						
Repair Type: Erosion						
Rating:Area of Concern						
Field Date:7/18/2017						
Notes: Small erosion and sloughing adjacent to revetted slope.

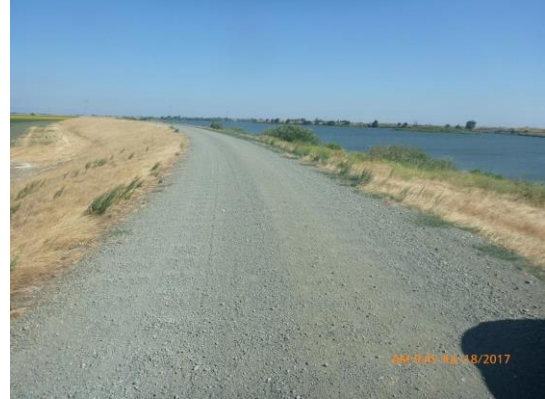
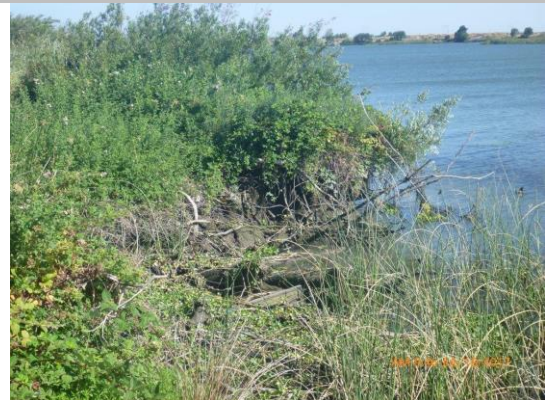
LM Start	2.69	Rating **	A/W	Issue No.	36
LM End	2.73	Issue Type +	Ma	Location *	
Category	Supplemental			GPS Latitude/Longitude	
				Start	End
Item	2017 Storm Damage			38.276608 °	38.276133 °
				-121.710811 °	-121.710394 °
DWR ID	DWR_RD2060_03_f _ 2017_36				
Comment Code					
Inspector Comment					
Levee Evaluation Comments					
Description:Sloughing commences approximately halfway down the slope and extends to the waterside toe.					
Site ID No:405					
Site Designation:LMA-232					
Repair Type: Erosion					
Rating:Serious					
Field Date:7/18/2017					
Notes: Vertical cut at highwater mark.

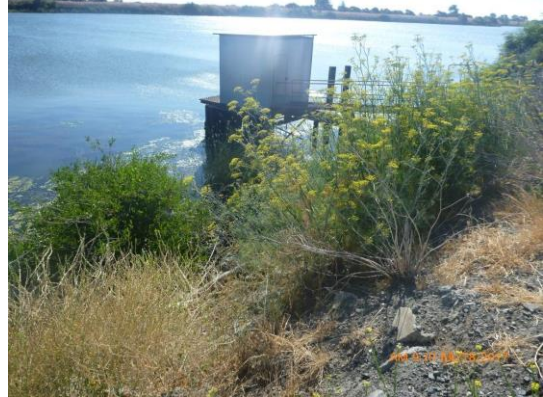
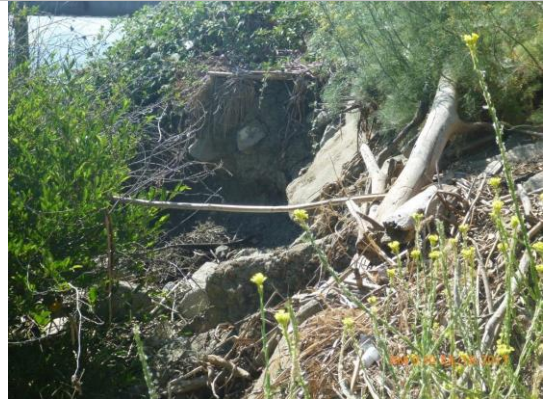
LM Start	3.24	Rating **	M	Issue No.	37 (cont)	
LM End	3.24	Issue Type +	Ma	Location *		
Category	Supplemental			GPS Latitude/Longitude		
				Start	End	
Item	2017 Storm Damage			38.270231 °	38.270203 °	
				-121.705897 °	-121.705856 °	
DWR ID	DWR_RD2060_03_f_2017_37					
Comment Code						
Inspector Comment						
Levee Evaluation Comments						
Description:Erosion commences approximately halfway down the slope and results in sloughing into the waterside toe. Existing rip rap has been pulled off the slope at this site.						
Site ID No:406						
Site Designation:LMA-233						
Repair Type: Erosion						
Rating:Area of Concern						
Field Date:7/18/2017						
Notes: Erosion is next to a pumphouse and slope is protected withrip rap.

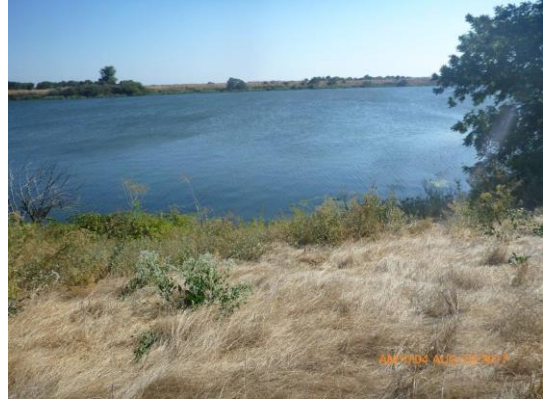
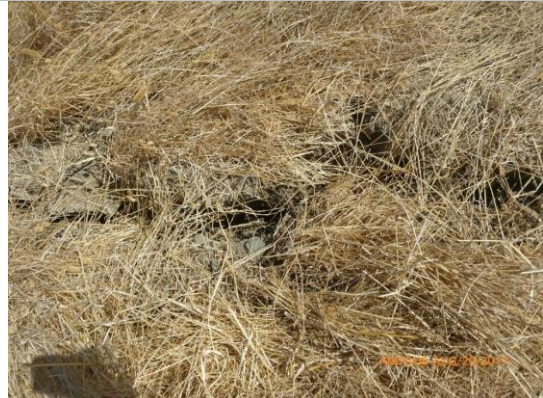
LM Start	3.59	Rating **	M	Issue No.	38
LM End	3.63	Issue Type +	Ma	Location *	
Category	Supplemental			GPS Latitude/Longitude	
				Start	End
Item	2017 Storm Damage			38.266408 °	38.266047 °
				-121.701650 °	-121.701061 °
DWR ID	DWR_RD2060_03_f_2017_38				
Comment Code					
Inspector Comment					
Levee Evaluation Comments					
Description:MBK Delta Erosion Sites_6-29-2017					
Site ID No:484					
Site Designation:LMA-322					
Repair Type: Erosion					
Rating:Area of Concern					
Field Date:8/29/2017					
Notes:

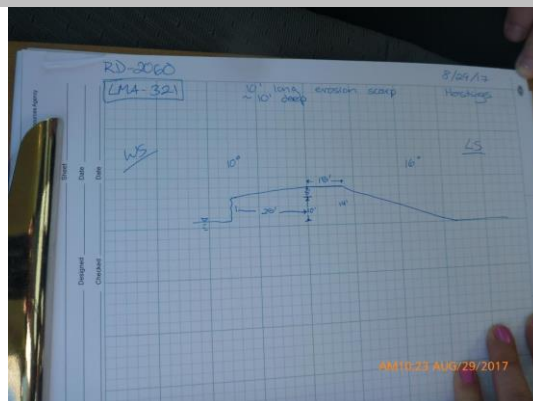
Photo 1 of 1 : FA\_2018\_RD2060\_243\_39\_20180925\_00066.jpg

LM Start	3.66	Rating **	M	Issue No.	39
LM End	3.71	Issue Type +	Ma	Location *	
Category	Supplemental			GPS Latitude/Longitude	
				Start	End
Item	2017 Storm Damage			38.265742 °	38.265342 °
				-121.700522 °	-121.699881 °
DWR ID	DWR_RD2060_03_f_2017_39				
Comment Code					
Inspector Comment					
Levee Evaluation Comments					
Description:MBK Delta Erosion Sites_6-29-2017					
Site ID No:483					
Site Designation:LMA-321					
Repair Type: Erosion					
Rating:Area of Concern					
Field Date:8/29/2017					
Notes:

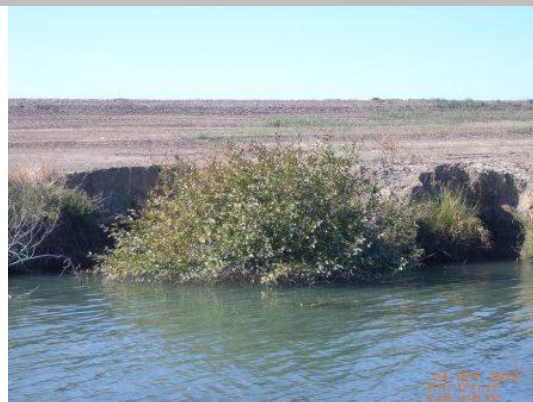
Photo 1 of 1 : FA\_2018\_RD2060\_243\_4\_20181105\_00089.jpg

LM Start	3.78	Rating **	A/W	Issue No.	4
LM End	4.09	Issue Type +	Ma	Location *	WS
Category	Supplemental			GPS Latitude/Longitude	
				Start	End
Item	2017 USACE Erosion Survey, DRAFT			38.264585 °	38.260593 °
				-121.698868 °	-121.696403 °
DWR ID	DWR_RD2060_03_f_2018_4				
Comment Code					
Inspector Comment					
2017 Site ID: CHS 21.1 R					
Status: Eroding					
2017 Field Notes: Significant toe erosion within last year.					
Site History: 2011 - Several pockets of erosion from rotational failure and slumping toe. 2013 - Site extended downstream to include new erosion pockets. 2016 - New rock in one of the erosion spots.

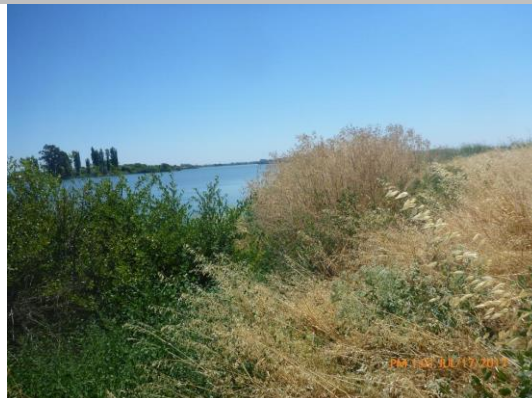
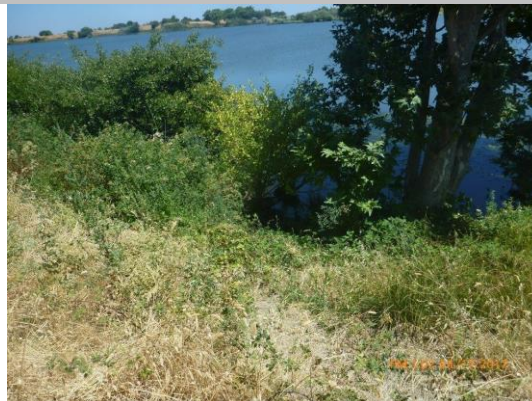
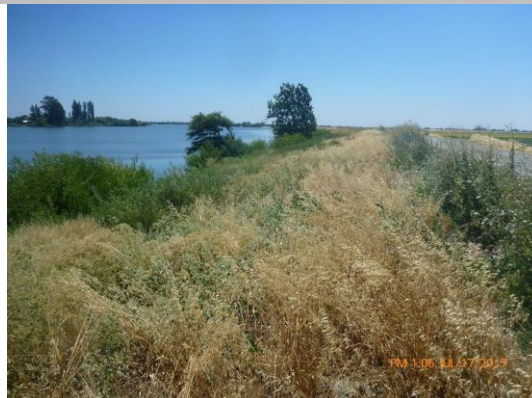
LM Start	3.82	Rating **	A/W	Issue No.	40
LM End	3.94	Issue Type +	Ma	Location *	
Category	Supplemental			GPS Latitude/Longitude	
				Start	End
Item	2017 Storm Damage			38.264006 °	38.262364 °
				-121.698811 °	-121.698103 °
DWR ID	DWR_RD2060_03_f_2017_40				
Comment Code					
Inspector Comment					
Levee Evaluation Comments					
Description:Erosion commences approximately halfway down the slope and results in sloughing into the waterside toe. Existing rip rap has been pulled off the slope at this site					
Site ID No:410					
Site Designation:LMA-237					
Repair Type: Erosion					
Rating:Serious					
Field Date:7/18/2017					
Notes: This site is combined with LMA-234. There is minor toe erosion along whole 631 lf, but there is a 20' wide deep erosion at 38.26347, -121.69859. That is the only location that is serious and is likely due toa collapsed beaver den.

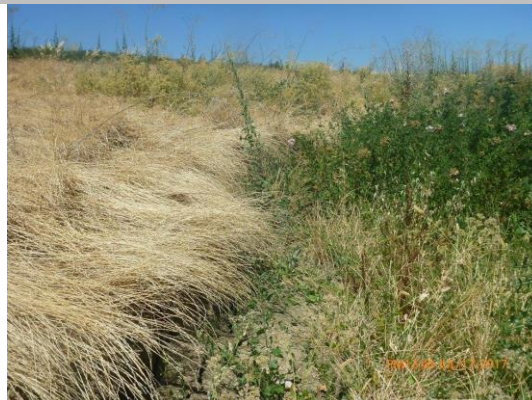
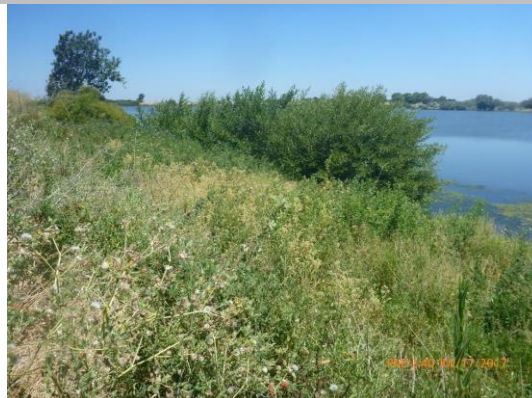
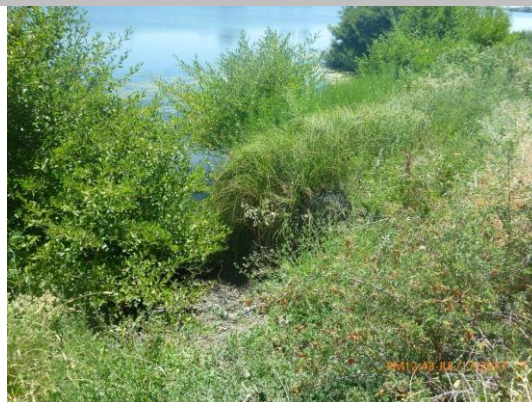
LM Start	3.96	Rating **	A/W	Issue No.	41
LM End	4.00	Issue Type +	Ma	Location *	
Category	Supplemental			GPS Latitude/Longitude	
				Start	End
Item	2017 Storm Damage			38.262114 °	38.261583 °
				-121.697978 °	-121.697647 °
DWR ID	DWR_RD2060_03_f_2017_41				
Comment Code					
Inspector Comment					
Levee Evaluation Comments					
Description:Erosion commences approximately halfway down the slope and results in sloughing into the waterside toe.					
Site ID No:411					
Site Designation:LMA-238					
Repair Type: Erosion					
Rating:Serious					
Field Date:7/18/2017					
Notes: This site includes LMA-235. Wide erosion looks like several small sited merged. Heavy veg indicates slow erosion.

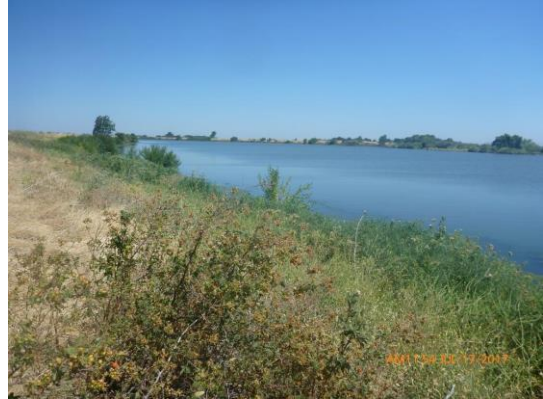
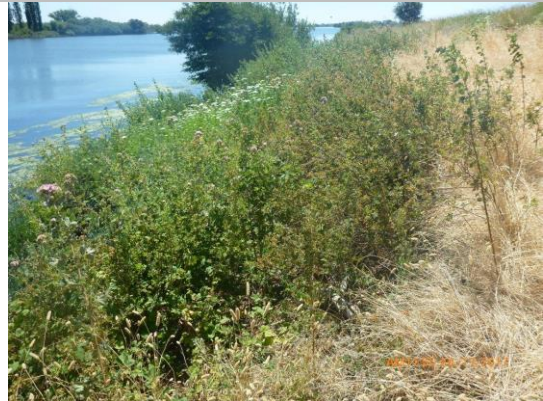
LM Start	4.06	Rating **	A/W	Issue No.	42
LM End	4.08	Issue Type +	Ma	Location *	
Category	Supplemental			GPS Latitude/Longitude	
				Start	End
Item	2017 Storm Damage			38.260789 °	38.260644 °
				-121.696964 °	-121.696828 °
DWR ID	DWR_RD2060_03_f_2017_42				
Comment Code					
Inspector Comment					
Levee Evaluation Comments					
Description:Erosion commences approximately halfway down the slope and results in sloughing into the waterside toe. Existing rip rap has been pulled off the slope at this site.					
Site ID No:412					
Site Designation:LMA-239					
Repair Type: Erosion					
Rating:Serious					
Field Date:7/17/2017					
Notes: Small erosion. Appears that site grows slowly with each high water. The center of the eosion is a deep cut that extends below rhe waterline. Possible beaver den collapse.

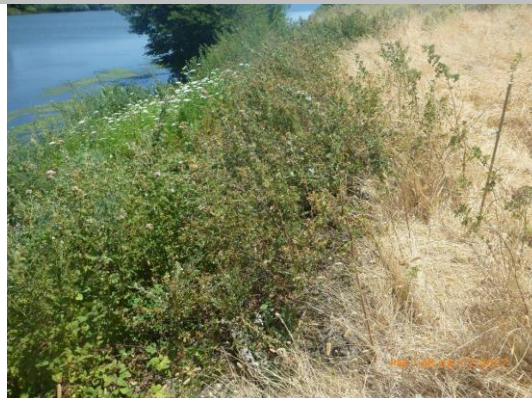
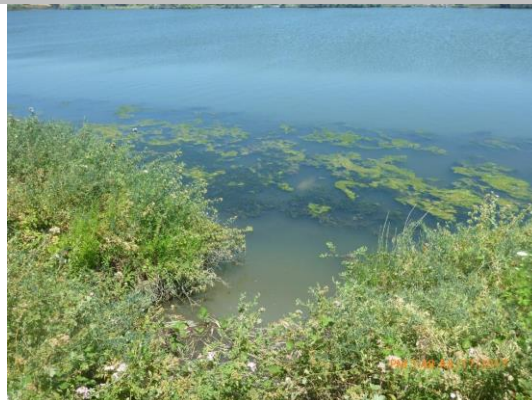
LM Start	4.06	Rating **	A/W	Issue No.	43 (cont)
LM End	4.08	Issue Type +	Ma	Location *	
Category	Supplemental			GPS Latitude/Longitude	
				Start	End
Item	2017 Storm Damage			38.260789 °	38.260644 °
				-121.696964 °	-121.696828 °
DWR ID	DWR_RD2060_03_f_2017_43				
Comment Code					
Inspector Comment					
Levee Evaluation Comments					
Description:Erosion commences approximately halfway down the slope and results in sloughing into the waterside toe.					
Site ID No:409					
Site Designation:LMA-236					
Repair Type: Erosion					
Rating:Area of Concern					
Field Date:7/18/2017					
Notes: 3' cut to slope down to water, with a 50' deep cut. Heavy veg suggests slow progression of erosion.
